Parts4Marx Tech Tips

005

GEX 4583 Searchlight Car

To troubleshoot the rotating searchlight mechanism:

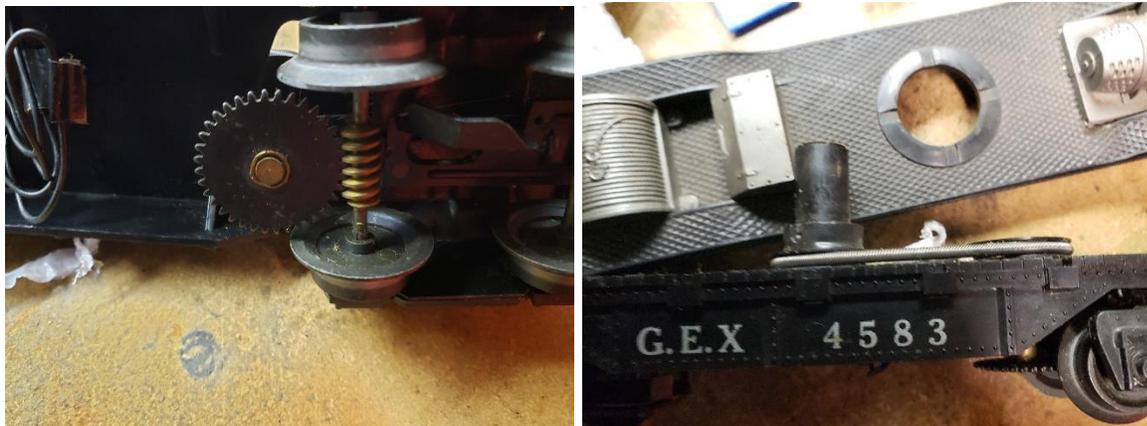
1. A worm gear on a truck axle turns a gear to spin an assembly inside the car. This assembly transfers rotation through a spring to a second wheel assembly to which the searchlight is attached.
2. Very carefully remove the deck off the car to access the inside assembly. It is glued, and the glued tabs will need to be freed.
3. Check that the spring hasn't come loose or broken and reattach if necessary.
4. Check that the rotating assemblies can move freely and clean them if necessary.
5. Replace the rotating searchlight. If it is missing or broken beyond repair RG Part No. 286 is a modified Lionel housing replacement for the searchlight.

Note: The center post that holds the light socket is thin and can easily break.
